JAugust 2021  
Idledale Water System Improvements Project

Orsatti Water Consultants

# Idledale Water System Engineering Study

Prepared for Idledale Water and Sanitation District

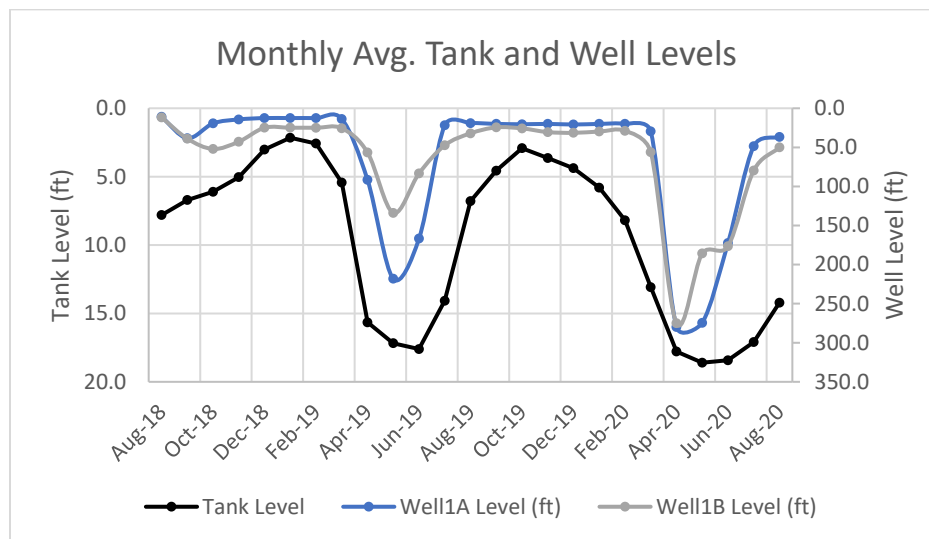
Figure 3.1: Monthly average tank and well levels

Figure 3.1 illustrates the supply-side issue the District is facing during the late spring to late summer. During this period, roughly April-August, the water levels present in the wells decrease significantly due to lowered groundwater recharge and high pumping rates. During this same period, water demand increases due to outdoor irrigation and increased domestic consumption. In response to the increased demand that exceeds production, the tank level decreases.

In the future when the District can maintain a surplus production supply year-round, the tank would remain full continuously for required fire protection supply and individual well production could be adjusted to lower levels on an average annual basis.

Annual high temperatures occur between June-September, with two peaks in precipitation in May and July. This two-peak precipitation pattern is due to early season cool rains of May and the warmer onset of the North American Monsoon in late June – July. During this drop in precipitation in June, aquifer storage begins to decrease after peak snowmelt has occurred. Groundwater levels in the Front Range of Colorado typically begin to steadily drop after peak snowmelt has occurred, unless precipitation remains high during the summer months. The precipitation trends in Figure 3.4 correlate with the decreased groundwater levels observed at Wells 1A and 1B in Figure 3.1.

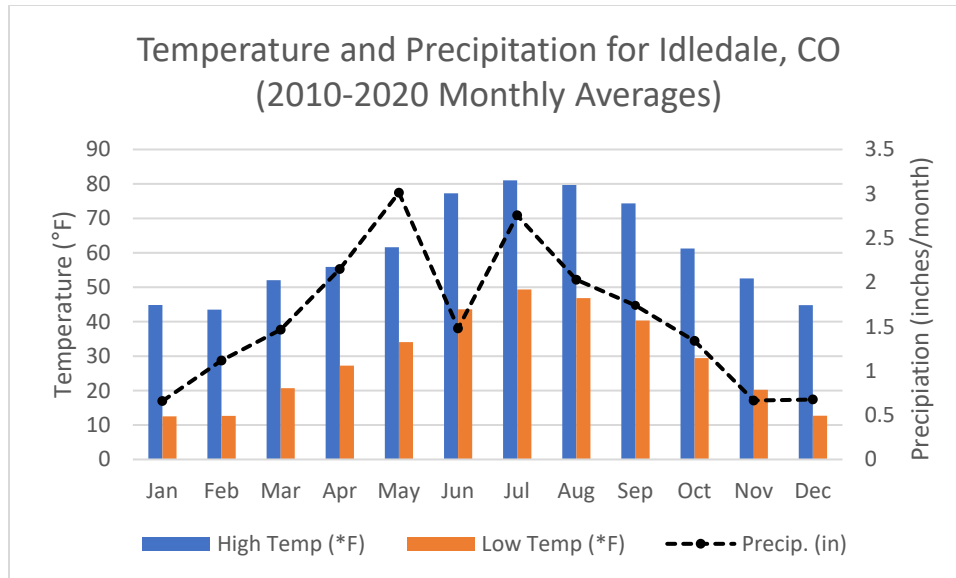
Figure 3.4: Temperature and precipitation for Idledale based on climate records from 2010-20 (CCC, 2020).

The Idledale Water and Sanitation District is located in a high-elevation, semi-arid zone of marginal precipitation. Monthly average high and low temperatures and average monthly precipitation rates are shown below in Figure 3.4.

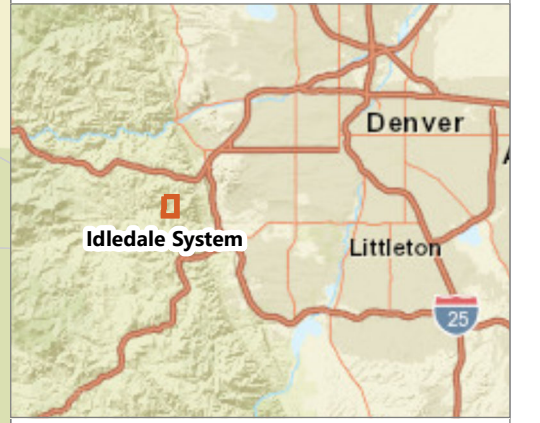
- ▲ Building
- ⊗ Isolation Valve (IV##)
- Land Parcels

**NOTES:** Parcel data from Jefferson County GIS portal. Accessed 7/30/2020

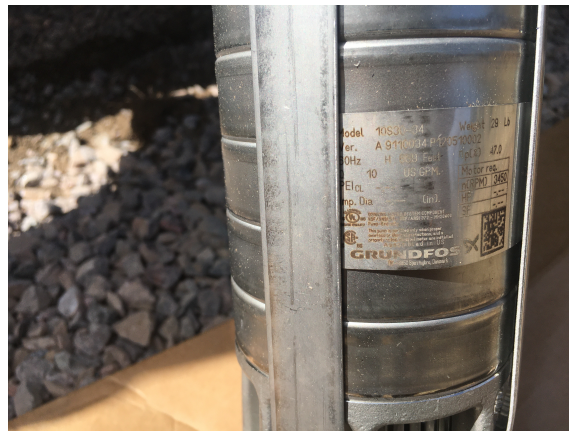
Grundfos Wet End

The initial removal of the old pump and installation of a new pump and motor (Grundfos 10S30-34 3 HP wet end with a 5HP Grundfos 3 phase motor, addition of 1" diameter PVC piezometer pipe, and installation of all new submersible cable (#8/3 conductor with ground) from the pump set depth to the well head to a deeper depth (672') was performed on April 5, 2021.

After installation, negotiations took place and Idledale desired to raise the pump and motor up to above the uppermost screen because the pump was initially installed to a depth of 672' and motor cooling could not be guaranteed. The equipment was raised and Idledale staff requested start up on April 30<sup>th</sup> 2021. During the startup on April 30<sup>th</sup> Colorado Water Well (CWW) determined we had a motor issue and the motor installed was eventually confirmed to be the incorrect motor, a single phase motor instead of a three phase motor. On Saturday May 1, CWW removed equipment and reinstalled a new three phase 5 HP motor. We also set the equipment with a final pump intake setting depth of 608', bottom of the motor is at 610' (Top well screen is at 626'). Idledale staff set the water level transducer and made final terminations at the VFD as they had requested.

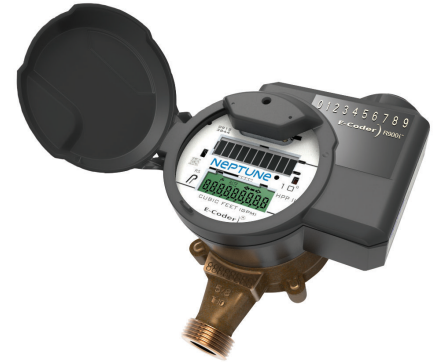
### Do More With Detailed, Actionable Data

The types of data your utility can generate through the E-CODER)R900i can take you far beyond a simple meter reading for monthly billing. Hourly consumption profile information over an account's last 96 days, along with alerts for leak or backflow, help to proactively identify and resolve customer issues – heading off high bill complaints, reducing delinquent payments, and eliminating write-offs. Using Neptune® 360™ host software, your utility can leverage detailed data from the E-CODER)R900i to balance water produced versus water consumed, group accounts for District Metered Area analysis, and track and manage Non-Revenue Water. From increasing efficiencies to pinpointing possible tamper or water theft to aiding customer service, the data supplied by the E-CODER)R900i can help your utility make better, more informed decisions.
